AFTER THE FIRE

The Conservation and Repair of Royston Parish Church

Kate Gunner

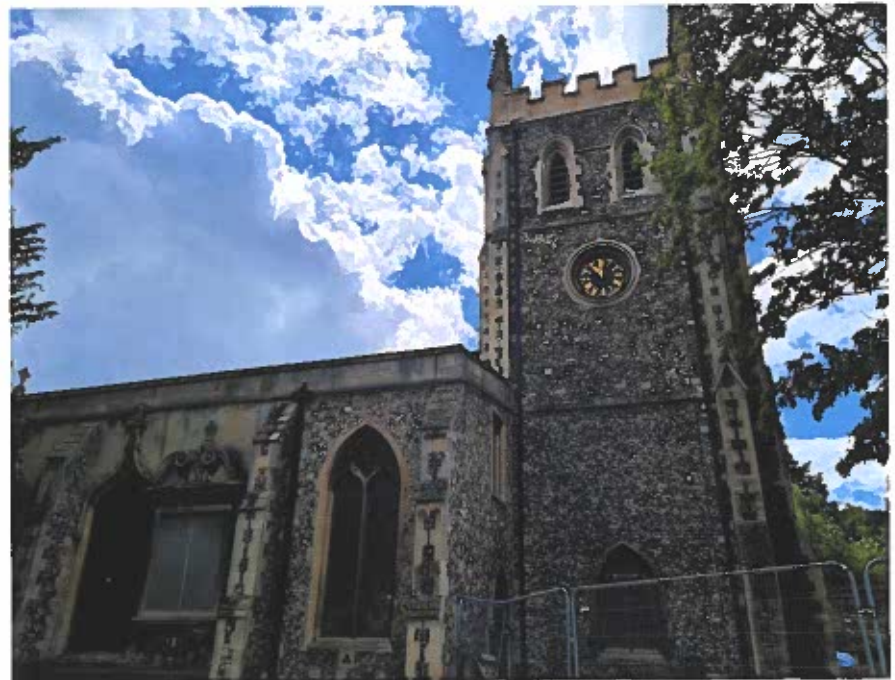
The fire devastated the tower where it started, including the bell ringing chamber and all interior woodwork. Significant damage was also caused to the west end of the nave and aisles, which were built around 1250 and originally formed the quire and sanctuary of a large church belonging to the Augustinian Priory of Royston. The church suffered from subsequent damage including the partial collapse of the nave roof, and the failure of several areas of the floor where there were underlying voids as a result of the water used to extinguish the fire. The interior and contents of the whole church suffered extensive smoke damage.

The tower where the fire started (All photos: Kate Gunner)

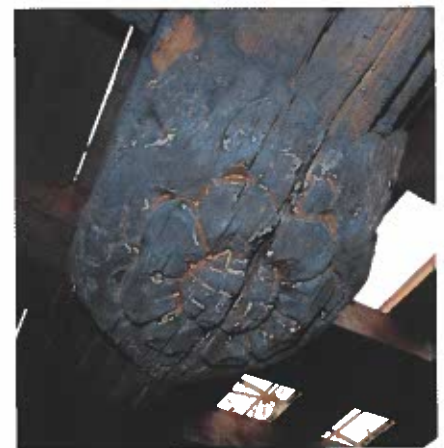
Charred surface of a boss from the ceiling of the nave

When all timbers were being ice blasted to remove fire and smoke damage, it was realised that it would be impossible to remove the charring without losing some of the carved inscriptions, historical graffiti and fine detail of the roof bosses. The inscriptions on the roof timbers record former church wardens, reverends and people within the community as far back as 1601, and although damaged by the fire, they are still legible. Bakers of Danbury employed conservators Hirst Conservation to carry out a survey, analyse samples and provide a review of treatment options. The conservators recommended that the historic graffiti should be stabilised and their appearance retained. For the carved inscriptions and roof bosses Hirst Conservation adopted a tailored treatment for each, as they were fire damaged to varying

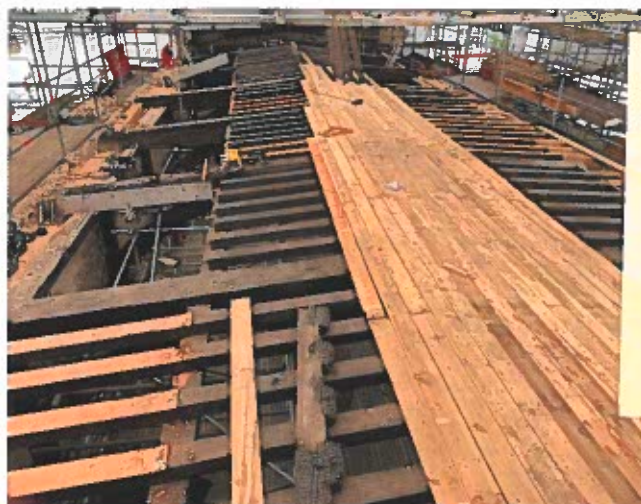
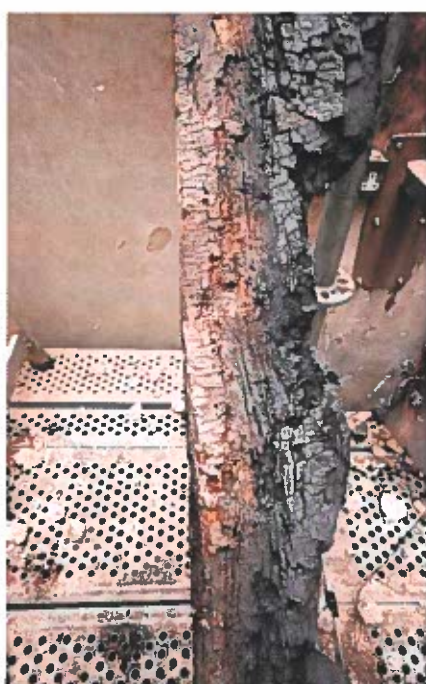
Not all the roof timbers could be salvaged.

brackets weighing in excess of 175 kg each. The common rafters were repaired and cleaned, or replaced where beyond repair.

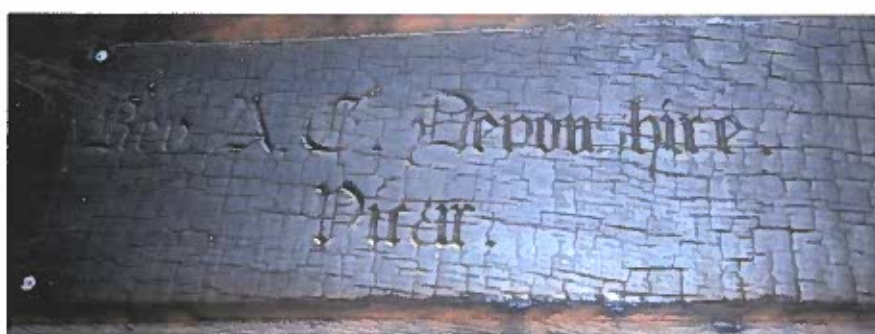
One of the carved inscriptions that would have been lost if the whole timber had been cleaned

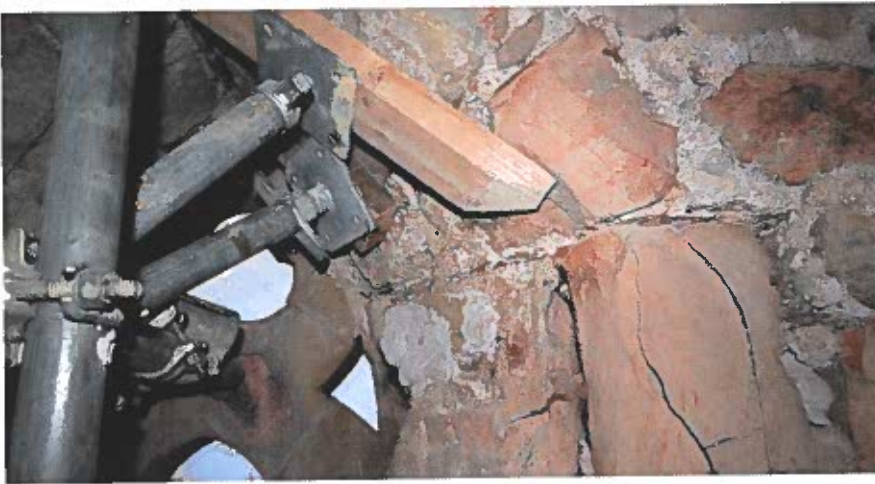
Cracked and spalling masonry in the tower caused by the cooling effects of water from the fire hoses when fighting the fire

Bakers of Danbury's team carried out extensive repairs to the internal walls of the tower, particularly at the belfry level where it had been damaged by the intense heat and by the large volumes of water used to extinguish the fire. Tottenhoe was sourced to match the original clunch (a chalky form of limestone) and used to replace the inner jambs to all ten of the lancet-arched openings to the tower. This required around 300 new shaped jamb stones and all new Welsh slate louvres. Repairs to the interior of the tower required over 500 new ashlar stones and the walls had to be completely re-pointed using lime mortar. Large structural fractures found when the plaster was fully removed were stitched with large pieces of stone, and the walls finally covered with limewash. A stone quatrefoil window was replaced using

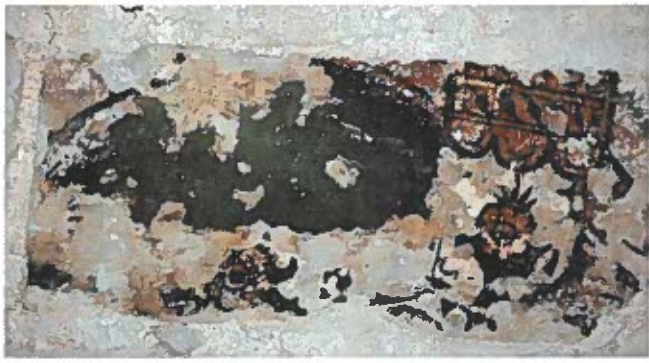
As the damaged plaster was being removed from the south wall of the north aisle, fragments of historic painted decoration were revealed in the spaces between arches. At the request of the property consultants, wall paintings specialists Tobit Curteis Associates were brought in to undertake an initial inspection of the painted decoration and to make recommendations for its protection and conservation. The painting was limited to specific blocks of clunch and in all cases the scheme was found to have been painted directly onto the blocks – indicating that the decorated limestone blocks had been reused from an area once covered by a large-scale scheme of decoration. The painting is obscured by post medieval limewash residues remaining on the surface.

Painted decoration from the late 15th or early 16th century which was uncovered during the work

Tobit Curteis Associates stated that style of the painting indicates it is of the late 15th or early 16th century, and the detail and materials indicate that it is finely painted and of significance. Of the details that are visible, there is clearly a background of foliage, including grass and a section of a painted timber with a knot. The ornate decorative details may be elaborate architectural decoration or details of fine cloth and clothing. The subject of the painting is unclear, but the details are all ones which are commonly found in Crucifixion and Doom paintings of the period. As part of the conservation of the painted decoration, they were recorded and covered over again.
