Restoration of Bourn Mill

Bakers of Danbury Ltd

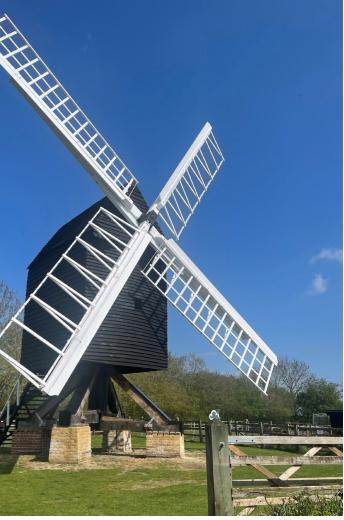
Figure 2 - The buck supported by the vast wooden trestle

The buck is supported by a vast wooden trestle of 4 oak beams; the horizontal cross trees and angular quarter bars. These are suspended and supported on four brick piers. Following a routine inspection of the mill at the beginning of 2020, it was these beams where extensive decay was discovered, raising a real concern about the future of the mill.

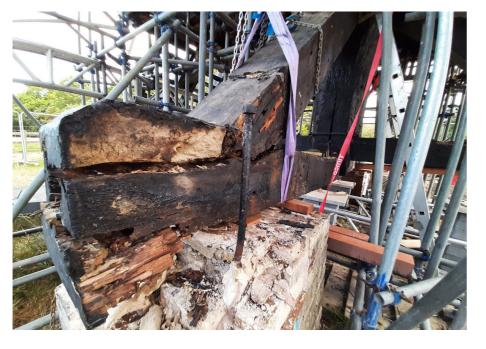
"a sand and cement type material, which we had imagined had been used only in a limited way as a filler for small defects, was actually extensively distributed in the centre of all four crosstree arms. The wood surrounding this sand and cement material showed rot in several places and it appeared that rainwater was infiltrating the structure of the crosstree arms".

The timber had in fact so significantly deteriorated that it became alarmingly apparent that these beams were providing little structural integrity to support the weight of the buck. The rotten timbers were also suffering from wet rot displaying cubing and a white bloom and although dry rot was not in evidence, the timbers were at the stage where this could occur, the resulting spores of which would be catastrophic to the timbers of the mill.

△ Figure 3 -Figure 4 -Extensive rot and decay to the oak beams

To alleviate stress on the supporting beams and reduce the impact of the wind, the mills sails were detached. A system of scaffolding and propping was then employed providing the essential support to stop the mill from collapsing. The mill was temporarily closed and Historic England placed the mill on the "Heritage at Risk Register".

A team of specialists undertook an extensive investigation programme from which it was determined the existing supporting timbers were irreparable. A replacement programme with the primary goal of replicating and conserving as many of the original timbers as feasible was formulated. Preservation and repair was at the heart of the plan.

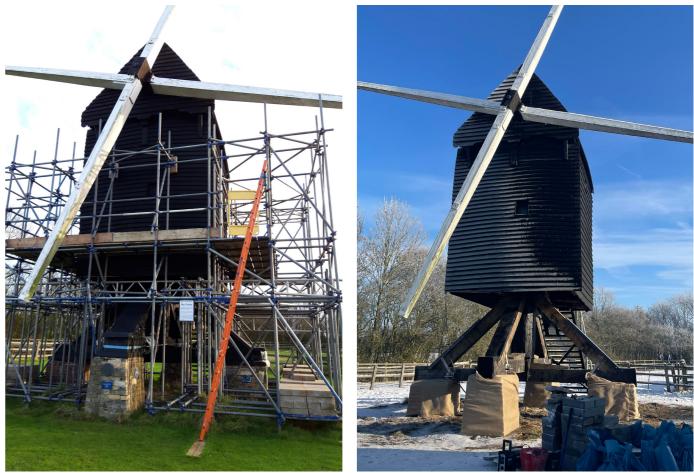
Figure 5 -Completed repair of the oak beams with rain covers fitted

Each new oak beam of colossal weight was firstly dry fitted before the final fix. The beam ends were treated in a beeswax oil then held in position with stainless steel bolts & brackets and bolted to the brick piers. The existing wedges between the cross trees and the main post were retained and reused.

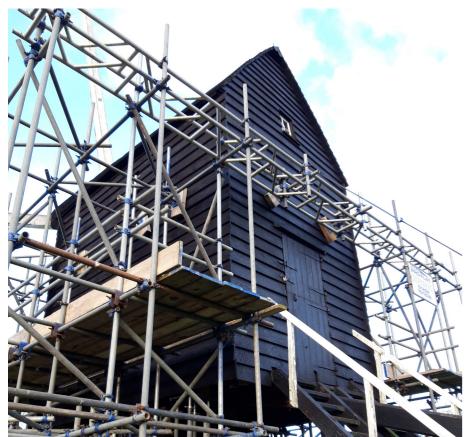
Figure 7 - Scaffolding down and hessian wrapped around rebuilt brick piers to protect from frost as the mill nears the end of its restoration

The brick piers providing the support for the beams were also reconstructed using lime mortar to match the original. There was a 30-day drying period to allow the lime to harden before the lowering process and the reconnection of the pivot plate and buck to the new trestle could take place.
