Restoration of St Lawrence Jewry Church

Bakers of Danbury Ltd, building contractors known for their specialism in heritage restoration, recently completed an extensive restoration programme at St Lawrence Jewry Church, an architectural gem standing in the yard of the London Guildhall in the heart of the City of London.

Commissioned by The City of London Corporation, the objective of the 18-month project was to restore and modernise the church and ensure its preservation for future generations. The project marked the largest phase of work to the building since it was reconstructed by city architect Cecil Brown in the 1950's and, as a £4million conservation project, it was the largest and most ambitious restoration of a Christopher Wren church seen for many years.

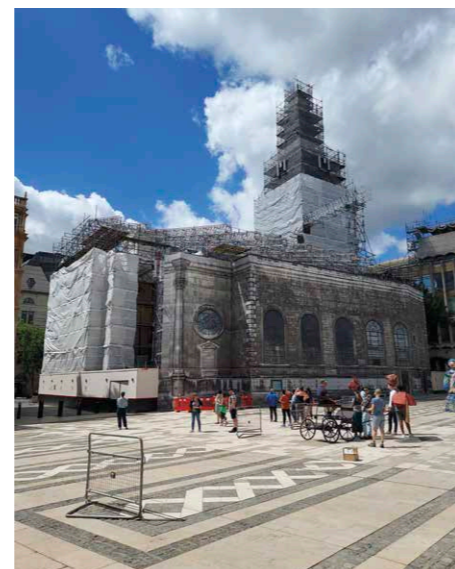
The external walls of the church were suffering from heavy carbon staining and discoloration, commonly found on city buildings where carbon monoxide particles from traffic settle onto brick and stonework causing blackened staining. A pattern of defects known as "corrosion jacking" was also evident, caused by concealed iron cramps rusting, expanding and subsequently splitting and cracking the stonework.

With many of the finishes to the roofs, gutters, cupola and spire coming to the end of their serviceable life, water penetration was also becoming an increasing problem and was starting to enter the fabric of the building.

The initial phase focused on exterior renovations involving specialised masonry cleaning and repair of the Portland stone elevations, tower and carved stonework.

Roofing upgrades were a priority with re-roofing carried out to the large roofing area to the south-west of the main tower, to the Commonwealth Chapel and the vicarage apartment. Renewal of roof finishes, including structural reinforcement and thermal upgrade on the lead covered Nave, was imperative. Repairs were made to the timber framed, leadclad cupola and spire with replacement of lead gutters and downpipes. In addition, the 11 striking stained-glass windows by renowned artist, Christopher Rahere Webb (1886-1966) were overhauled, cleaned and repaired.

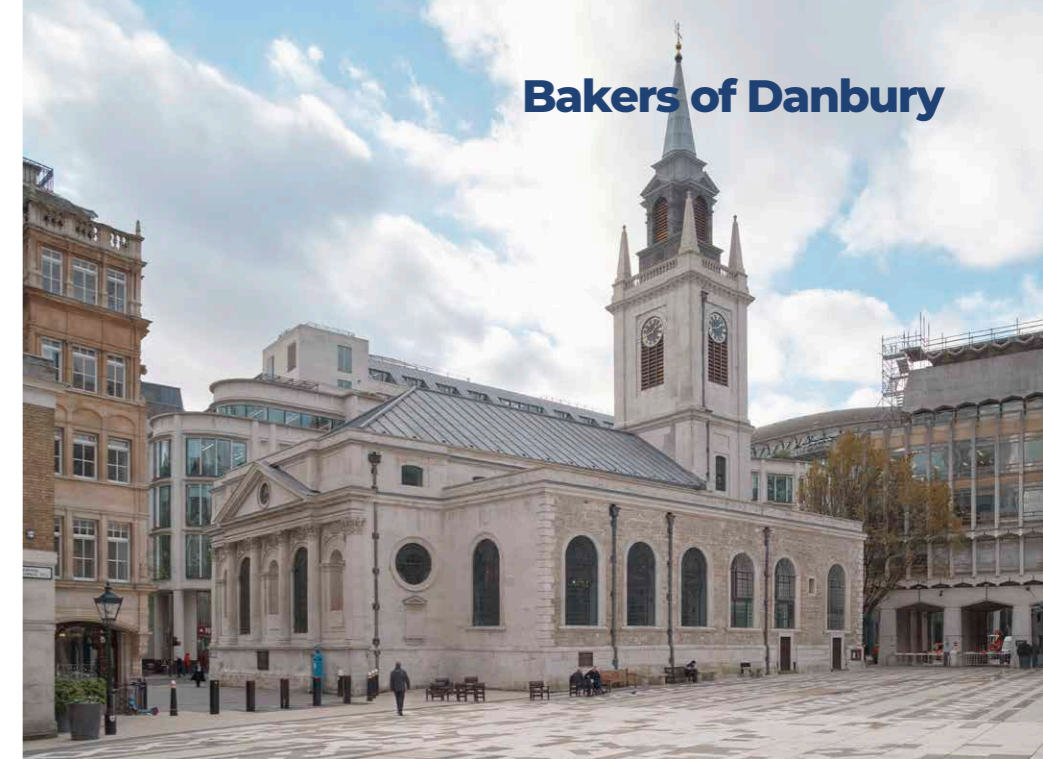
Weathervane Preserved

Illustrating this was the restoration of the weathervane. Sitting atop the tower,

the weathervane depicts a grid-iron, symbolising an instrument of torture which led to the martyrdom of St Lawrence. Its supporting pole is thought to be part of the WW2 incendiary bomb. On close inspection, possible only once the vast scaffolding was in place, it was found that the baseball which holds the weathervane upright had rotten. This was replaced and followed by meticulous cleaning and regilding, the weathervane was saved and restored back to its former glory.

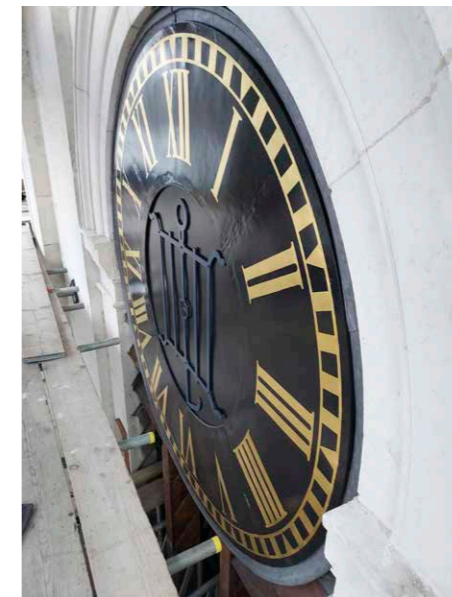
Clock faces restored

The restoration of the North, South, East and West clock faces in the tower demanded similar attention. Carefully removed and lowered to ground level in a cradle, the clock faces were transported to specialist clock restorers. There, the faces were resurfaced, and each Roman numeral regilded with fine gold leaf. With careful planning and onsite adjustments these magnificent clock faces and hands were then reinstated to their rightful place, proudly surveying over the City of London.
