Restoration of Bourn Mill

Bakers of Danbury Ltd

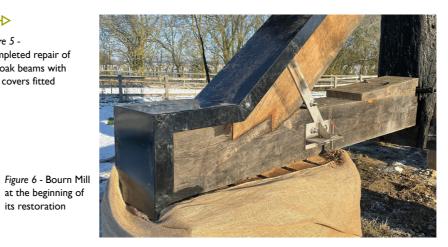
Figure 5 -Completed repair of the oak beams with rain covers fitted

Each new oak beam of colossal weight was firstly dry fitted before the final fix. The beam ends were treated in a beeswax oil then held in position with stainless steel bolts & brackets and bolted to the brick piers. The existing wedges between the cross trees and the main post were retained and reused.
